Confidential Inspection Report

**123 Elm St
Montvale, NJ 07645**

Report: 1834doe

Inspection Address: 123 Elm St ,Montvale, NJ 07645

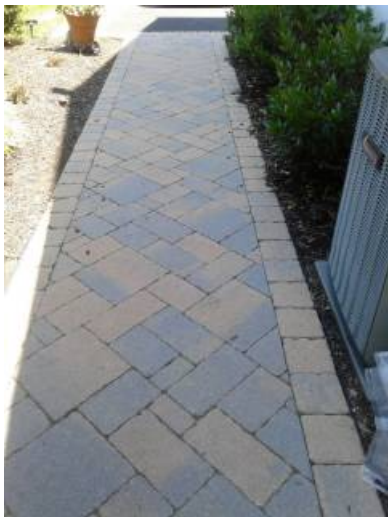
| Walks: | | | |

| <input type="radio"/> | <input type="radio"/> | <input type="radio"/> | <input type="radio"/> Sidewalk type: Paver/Tile. |

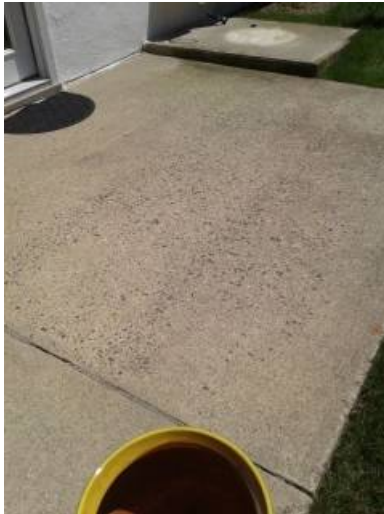
☐ ☐ ☐ ☐ Patio type: Concrete.

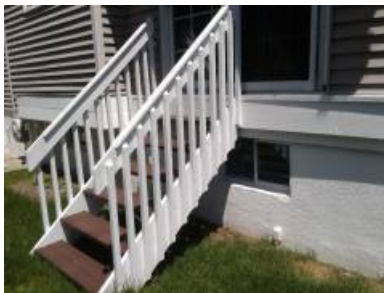
Since the deck is gone it might have been taken down because of the condition of the deck.

STRONGLY RECOMMENDED that you have it inspected and

DO NOT overload the deck with either a lot of people or put something on the deck like a hot tub.

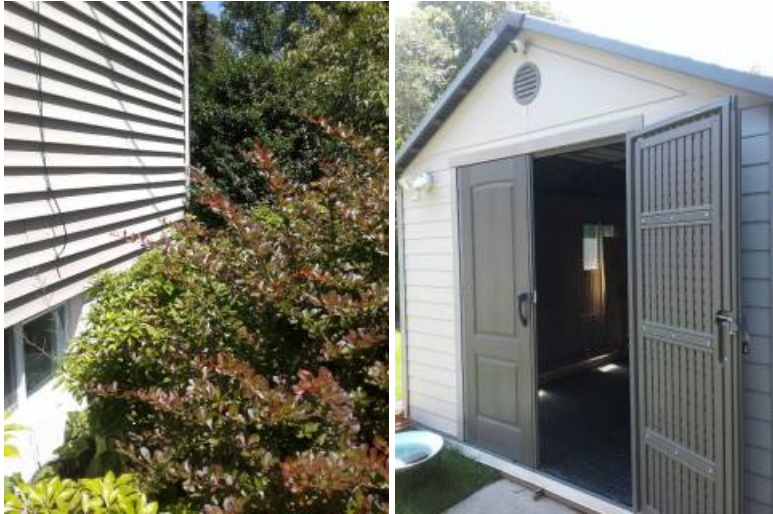
☐ ☐ ☐ ☐ Check with local charities like Habitat For Humanity to find out if they need shrubs or plantings for any of their projects.
If they need a donation like this ask them if they have volunteers that will dig them up and remove them.
Ask for a receipt for this "donation".
Play sets, Tree houses, sheds , out buildings and Koi ponds are not inspected are part of the Home Inspection and aren't included.
Maintenance tip: When landscaping keep plants even at full growth, at least 18" away from the house siding and windows.
Check FEMA Flood maps for additional information as is related to streams , rising waters and flood zone amps.
ALL of which are outside and beyond the scope of a Home Inspection.
Ponding is noted.
Fill in depressions and add top soil where needed.

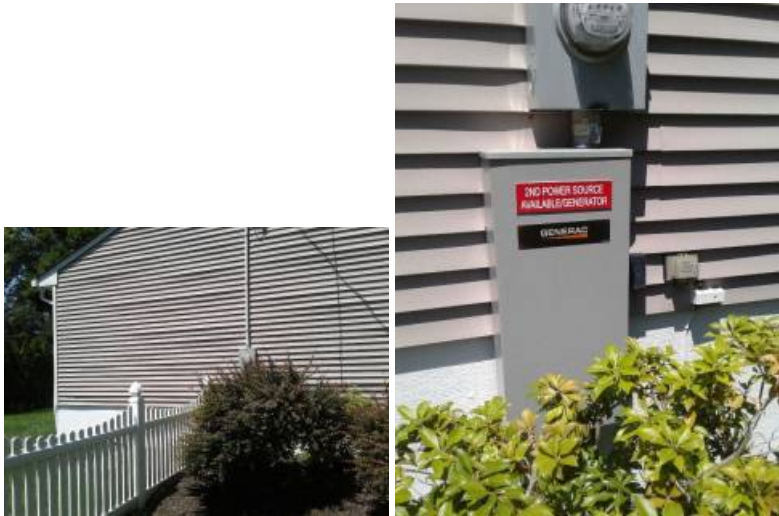
| OK | MM | RR | INOPERABLE | |
|---|---|---|---|---|
| <input type="radio"/> | <input type="radio"/> | <input type="radio"/> | <input type="radio"/> | There was a generator here at one time but it has since been removed. Electrical panel remains. |

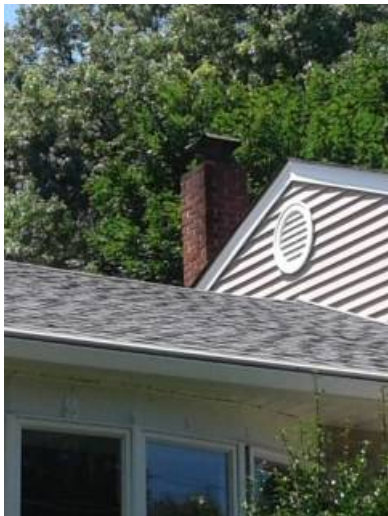
Chimney Exterior:

| <input type="radio"/> | <input type="radio"/> | <input type="radio"/> | <input type="radio"/> | Brick materials. Suggest rebuilding the weather cap / chimney crown to reduce the opportunity of water infiltration and damage. This is a common but important maintenance item. |

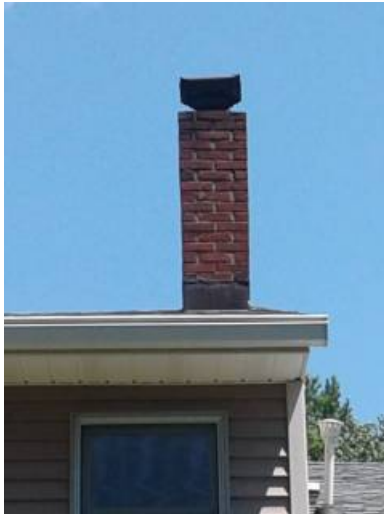
Flue:

| <input type="radio"/> | <input type="radio"/> | <input type="radio"/> | <input type="radio"/> | The fireplace flue was not checked from the top side. The inspector did not climb on to the roof or could not get to the chimney top. The inspection is limited to the visible portions of the fireplace flue. |
| Drop light, mirrors, and smoke testing are not a part of the inspection. Visibility is limited to as little as 20% of the flue. | | | | |

Have a licensed Chimney company do a Level 2 Inspection.

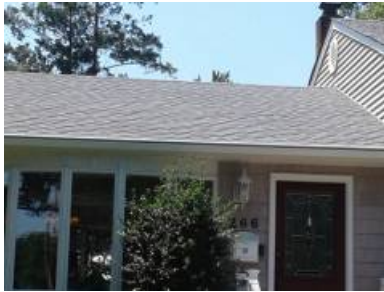
Pitched.

Unable to fully access due to height/pitch/weather/type,
A zoom lens on a camera and a camera were used to view the roof.

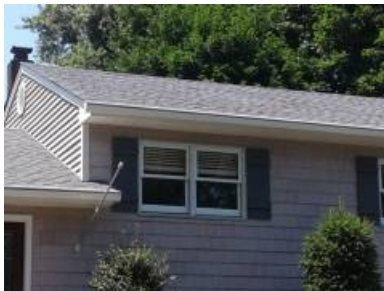
☒ ☐ ☐ ☐ Composition shingles.

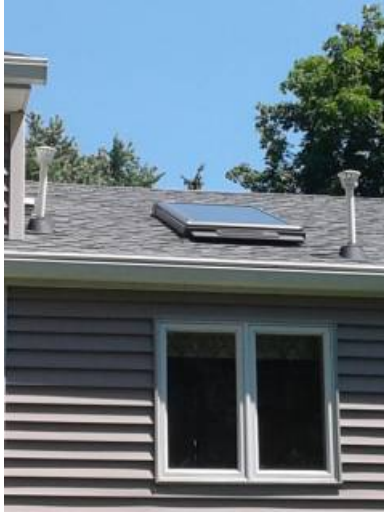
Skylights:

☐ ☐ ☐ ☐ Satisfactory - The skylight(s) appears to be satisfactory and shows no signs of leaking.
Consider installing a small cricket on the upper portion to divert water and snow from sitting on the high side.

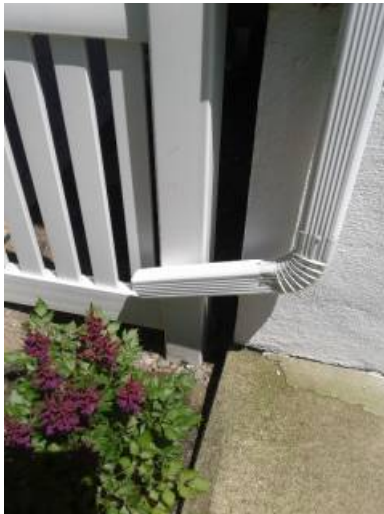
Significant amounts of debris evident. Clean the gutters seasonally. This is a small but very important item that should not be over looked as normal maintenance.

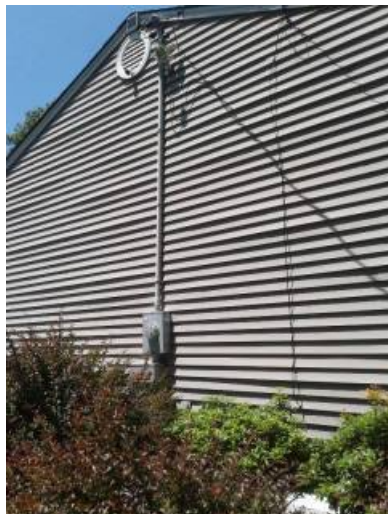
Type & Condition:

| <input type="radio"/> | <input type="radio"/> | <input type="radio"/> | <input type="radio"/> | Overhead, 110/220 Volt, Circuit breakers, 150 Amp service. |

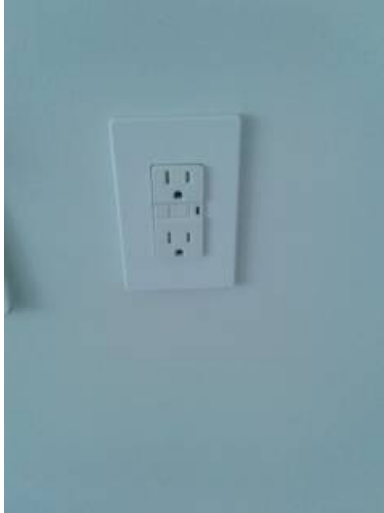
There is an opened outlet that needs to be covered.

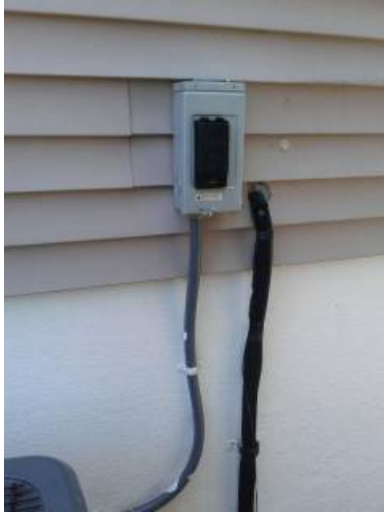
110 Volt, Electrical disconnect present.

Capacity / Approx. Age:
 ~ 2 ton unit from 2013.

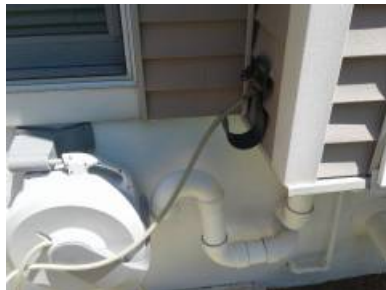
The temperature pressure relief valve at the upper portion of the water heater is a required safety valve which should be connected to a drain line of proper size terminating just above floor elevation. If no drain is located in the floor a catch pan should be installed with a drain extending to a safe location. The steam caused by a blow-off can cause scalding. Improper installations should be corrected.

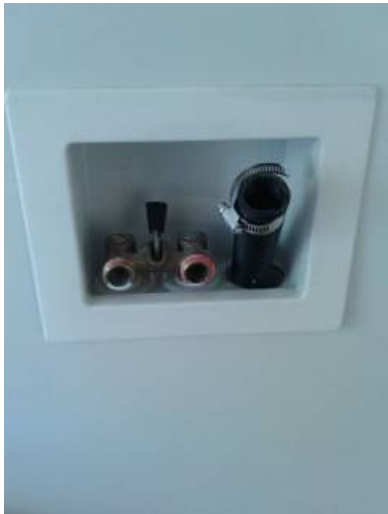
☐ ☐ ☐ ☐ Recommend installing metal braided burst resistant hoses. One web site you can visit for more information on this subject is at Watts.com. Check out the Watts Flood Safe Auto Shutoff Connectors. The braided stainless steel hoses have a valve that shuts off water if the flow on the demand side exceeds 2.9 gallons a minute. Installing these hoses can spare you serious headaches. None.

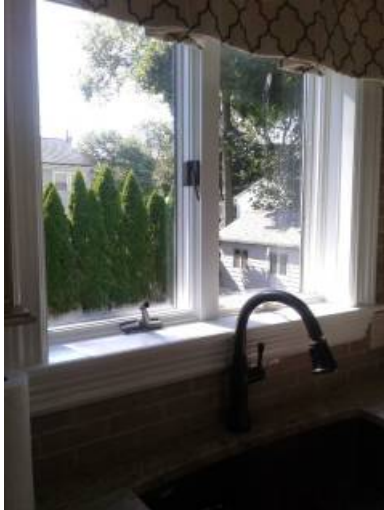
Kitchen Interior:

Screen missing from window(s). Check with the seller to determine if they are on the property.

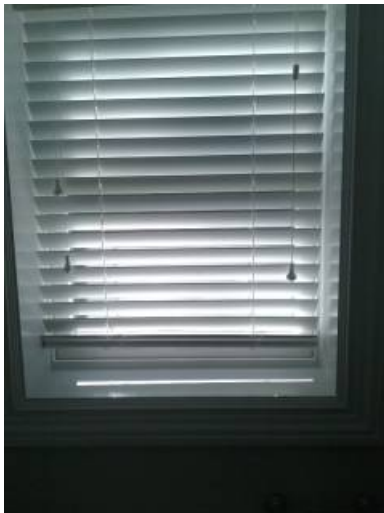
Master Bath:

There is no Tempered glass in the bathroom window. As close as it is to the tub/shower area, it should be Tempered glass.

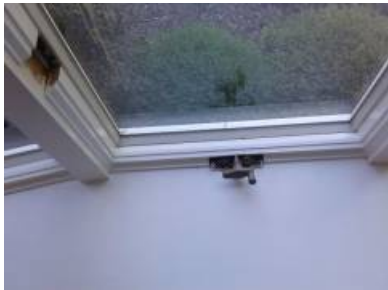
Living Room:

At least one window or associated hardware in this room needs repair. Hardware Screen missing from window(s). Check with the seller to determine if they are on the property.

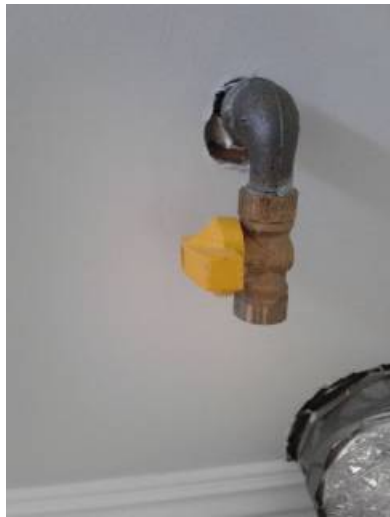
Fuel System:

The gas is uncapped and needs to be capped and or sealed by a licensed plumber until an appliance is ready to be hooked up to the gas line. Also make sure there is a working CO detector in this area.

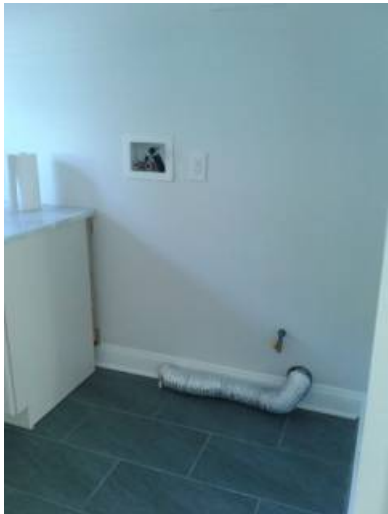
The washer and drier left with the Sellers. None here at the time of this inspection.

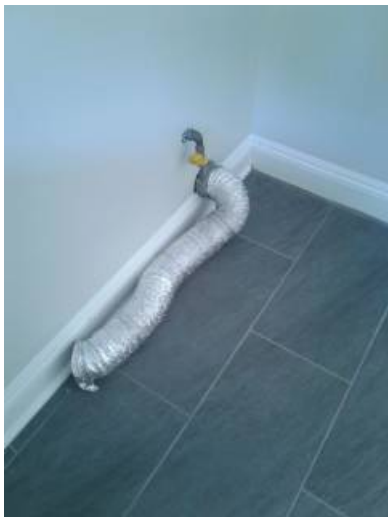
The US Product Safety Commission estimates that there were clothes dryers that were associated with ~ 16,500 fires in homes. It is important that the dryer and exhaust ducts be properly installed with the proper materials , cleaned and inspected annually and not kinked or crushed behind dryers.
We Recommend cleaning out the drier vent periodically of lint building up.

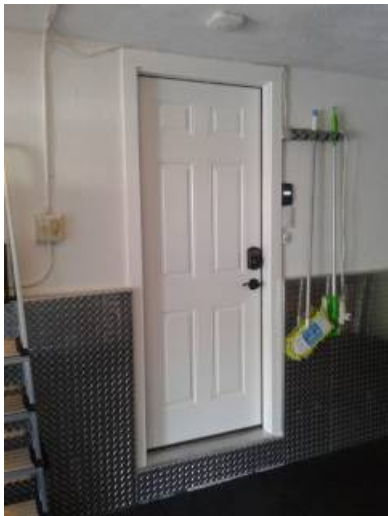
Service Doors:

Service door from garage to the house is Not self closing. For fire safety reasons it should be self closing.

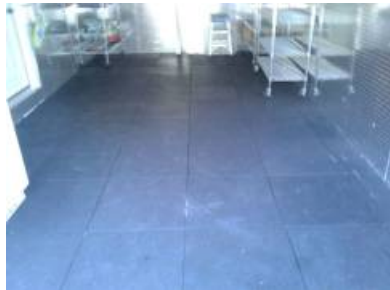
Concrete covered over with interlocking foam pads. This garage was converted to additional living space or some sort home gym workout area.
