Inspection Report

Address: 49 Sample Ave Montclair, NJ

Date: March 3, 2023

**Aurora Home Inspections, LLC
110 Chestnut Ridge Rd Suite 200
Montvale, NJ 07645
Phone: 201 819 4361
neallewis77@gmail.com**

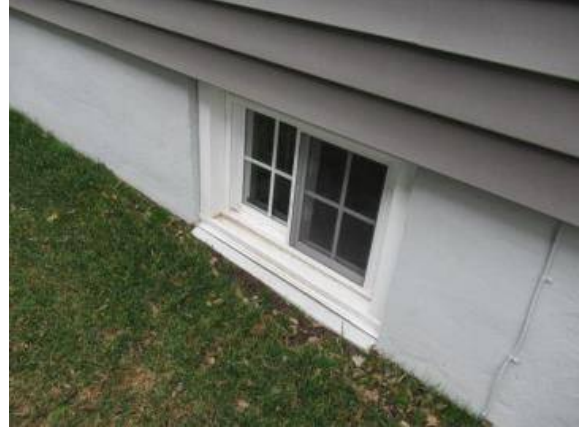
Attention Recommended- The grading height is near the bottom of the basement window. Install a window well and cover to prevent water entry through the window.

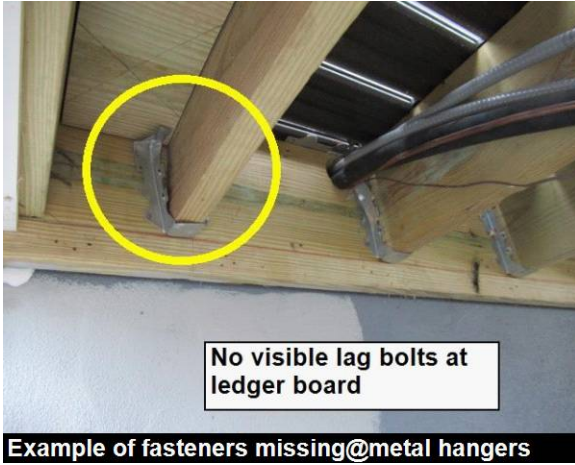
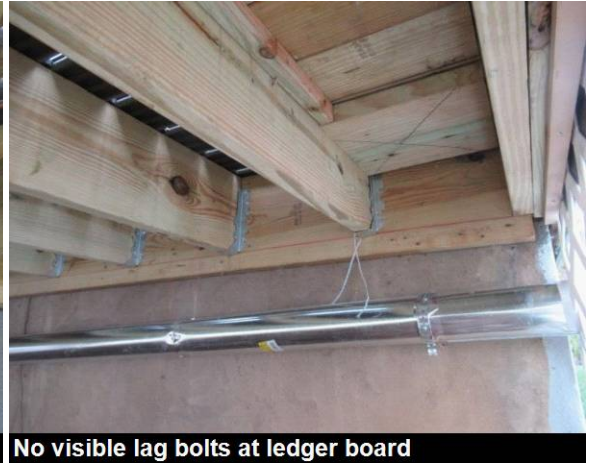
Condition of Deck Structure: **Action Needed-** The deck ledger board is not adequately secured to the house and is attached with nails only. Install lag bolts or approved fasteners for a positive attachment to the house to prevent movement or damage.

Action Needed- Some fasteners are missing at the metal joist hangers. Additional fasteners should be installed to properly secure the joist hangers.

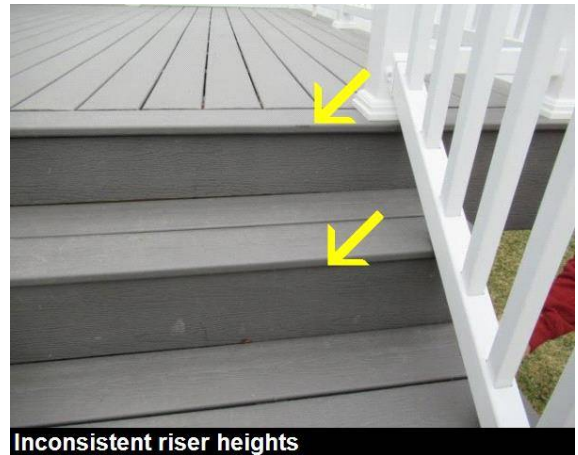
Attention Recommended- The riser heights at the steps is inconsistent. Repair for increased safety.

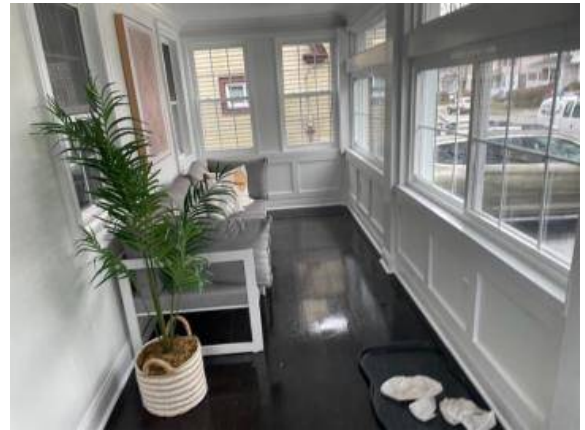
Enclosed Porch

Condition of Porch: Acceptable- The enclosed, unheated porch was in acceptable condition.

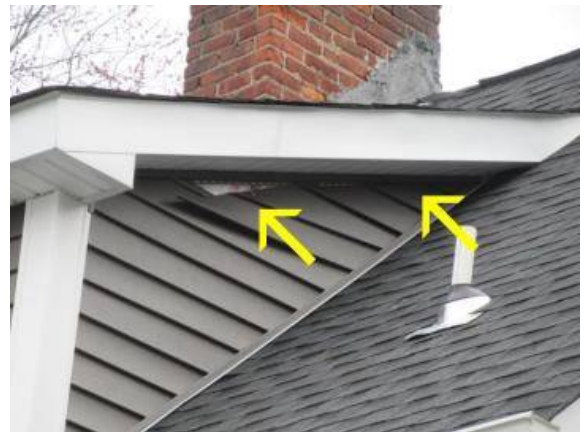
Siding Condition: **Action Needed**- The loose siding should be repaired at the front left for proper weather protection.

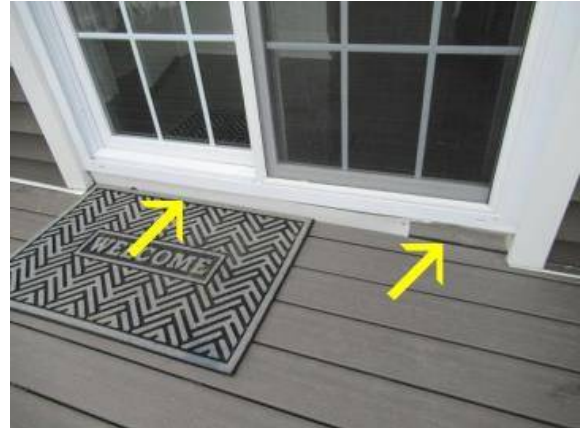
Attention Recommended- The front exterior door is binding. Trim or adjust the door.

Attention Recommended- A full length kickplate is missing under the sliding glass door.

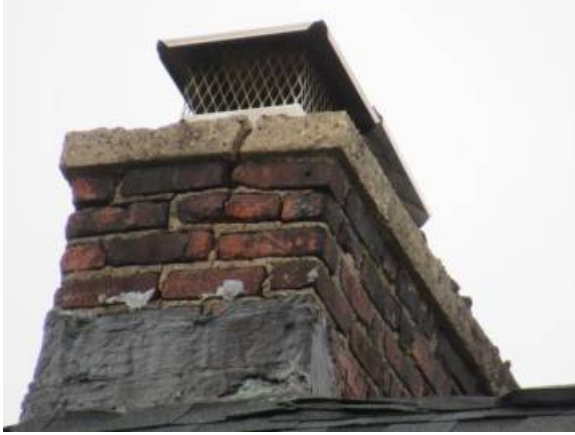
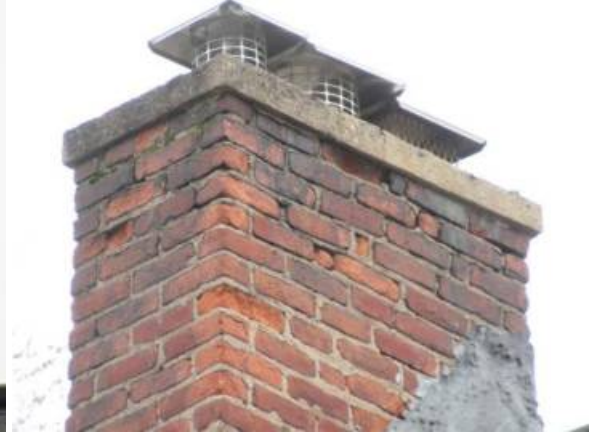
Chimney Condition: **Action Needed-** There are worn/cracked mortar joints and loose bricks at the masonry chimney. Significant repair is needed to prevent further damage.

Please Note- The masonry chimney flashing is coated with tar/roof cement, apparently to correct previous leakage. The tar will dry and crack and is not a long term repair. Monitor and expect to repair/reseal the flashing.

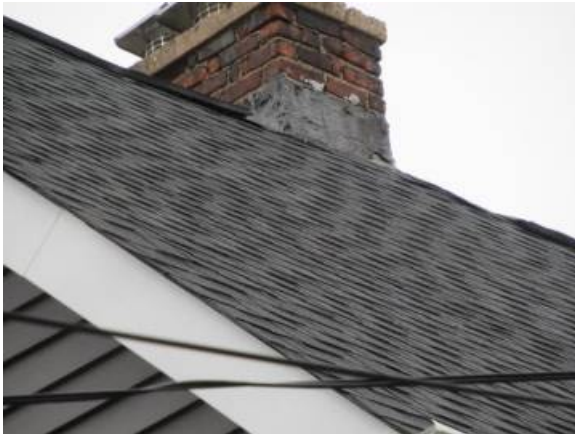
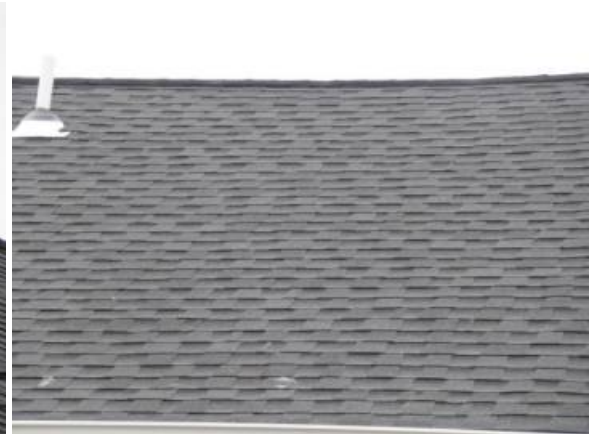
Roofing Surfaces

Roof Style: Gable

Roofing Materials: Asphalt/fiberglass composition shingles

Condition of Roof: Acceptable- The visible roof sections are in acceptable condition, with no deficiency or cause for immediate concern.

Flashing: **Please Note-** The chimney flashings are coated with tar/roof cement, possibly to correct previous leakage. The tar will dry and crack and is not a long term repair. Monitor and expect to repair/reseal the flashings.

Attention Recommended- The heating system metal flue is coated with a sealant. This is a less than professional installation.

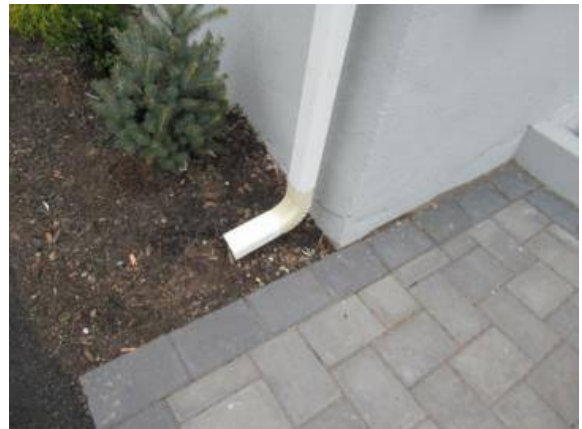
Attention Recommended- Downspouts are discharged near the foundation, which can contribute to water penetration/seepage at foundation walls. Install extensions to discharge water away from the foundation.

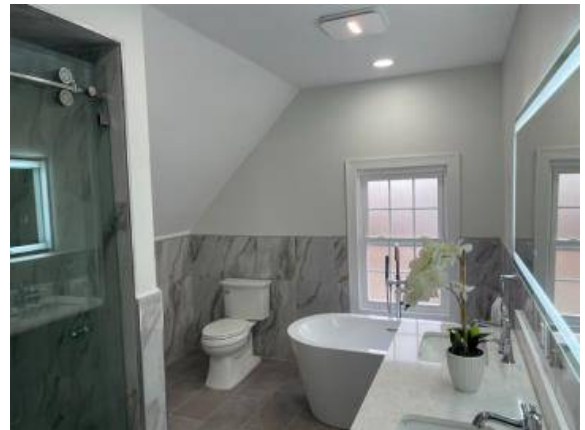
Full Bathroom #1

- Entry Door:** Acceptable- The bathroom door is acceptable/functional.
- Walls/Ceilings:** Acceptable- The walls and ceiling are in acceptable condition.
- Floor:** Acceptable- The bathroom floor is in acceptable condition.
- Window(s):** Acceptable- The bathroom window is in acceptable condition.
- Ventilation Fan:** Acceptable- The exhaust fan is functional.
- Light Fixtures:** Acceptable- The light fixtures are functional.
- Outlet(s):** Acceptable- The outlets tested are in acceptable condition. The outlet(s) is Ground Fault Circuit Interrupter (GFCI) protected and is functioning properly. This type of safety device helps to protect against an electrical shock hazard.

Water Flow/Drainage: Acceptable- Water flow/pressure and drainage at the bathroom fixtures is functional.

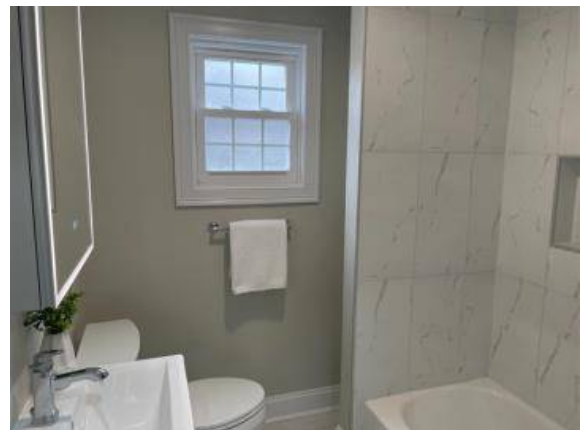
Full Bathroom #2

Entry Door: Acceptable- The bathroom door is acceptable/functional.

Walls/Ceilings: Acceptable- The walls and ceiling are in acceptable condition.

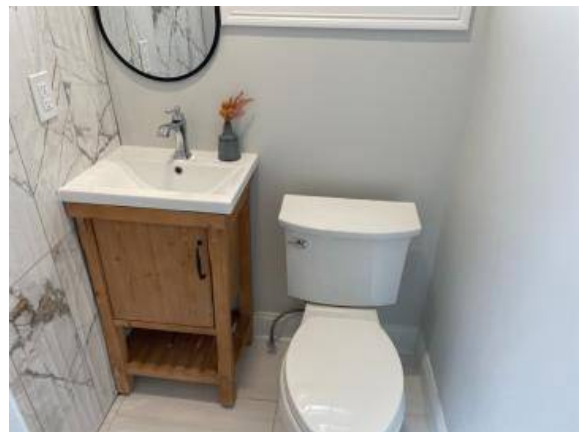
Partial Bathroom #1

Entry Door: Acceptable- The bathroom door is acceptable/functional.

- Walls/Ceilings:** Acceptable- The walls and ceiling are in acceptable condition.
- Floor:** Acceptable- The bathroom floor is in acceptable condition.

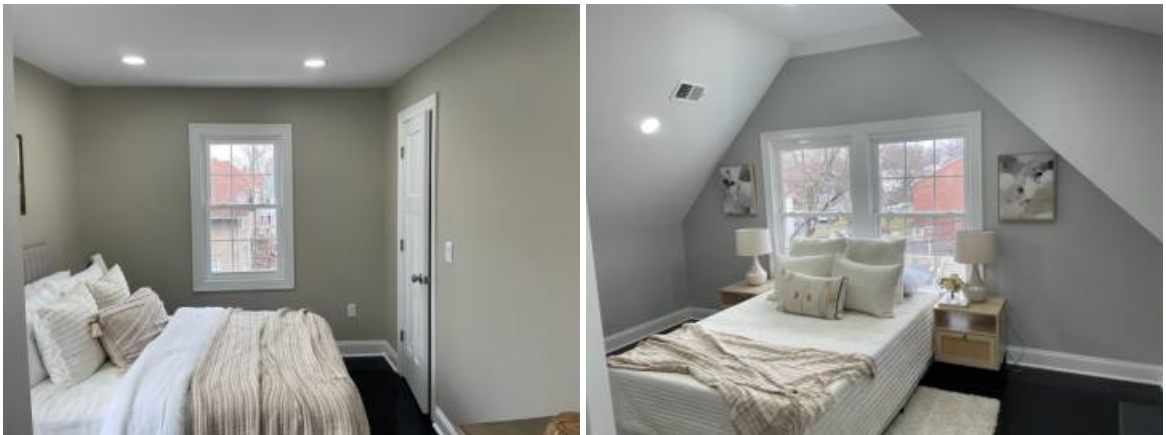
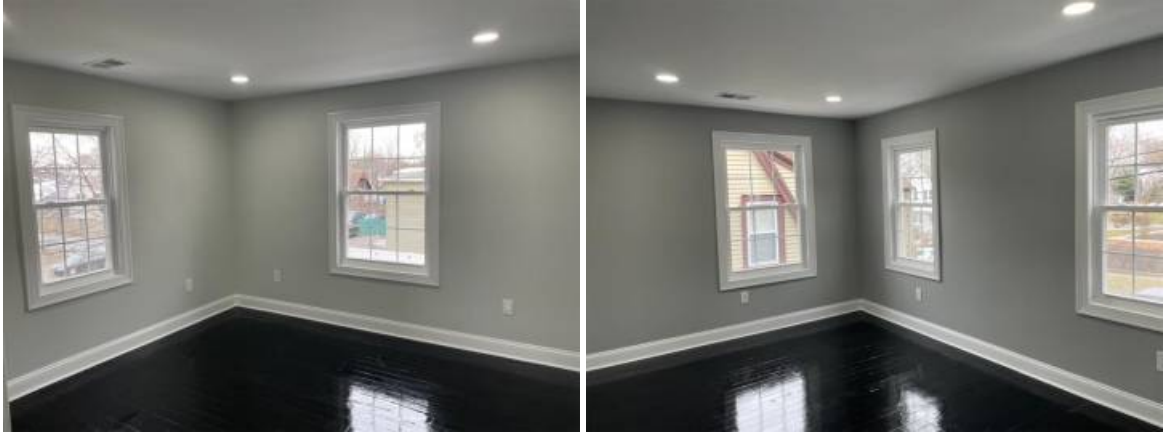
BEDROOMS

- Entry Doors:** Acceptable- The entry doors are in functional/acceptable condition.
- Closets:** Acceptable - The closet doors are functional. The closet interiors are acceptable, where accessible.
- Walls/Ceilings:** Acceptable- The walls and ceiling are in acceptable condition.
- Windows:** **Action Needed-** The front bedroom right side window can fall/tilt out when opened due to improper installation. Repair is needed for safe use.
- Outlets, Switches & Fixtures:** Acceptable- The switches and outlets tested are in acceptable condition. A representative number of accessible outlets are tested.
- Floors:** Acceptable- The visible floor areas are in acceptable condition. The floor covering materials are wood.

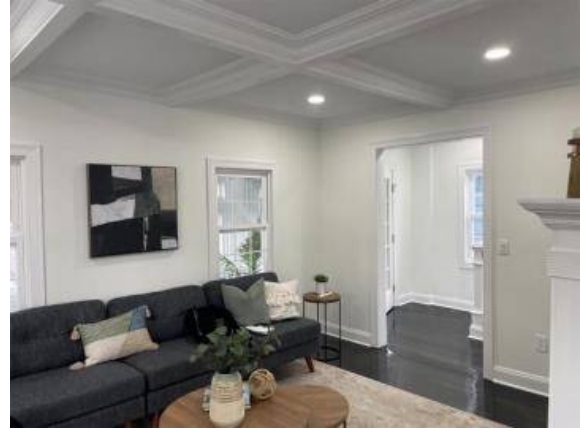
LIVING AREAS

Entry Door(s): **Attention Recommended-** The front exterior door is binding. Trim or adjust the door.

Acceptable- The sliding glass entry door is in functional/acceptable condition.

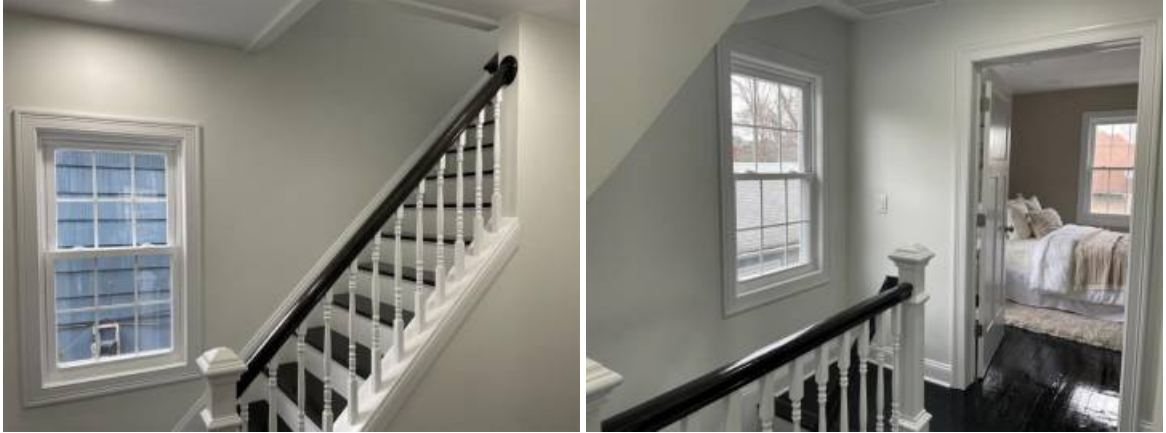
Railings: **Attention Recommended-** There is a partial railing only at the third floor stairs. The railing is not continuous. Install an additional length handrail for increased safety at the third floor stairs.

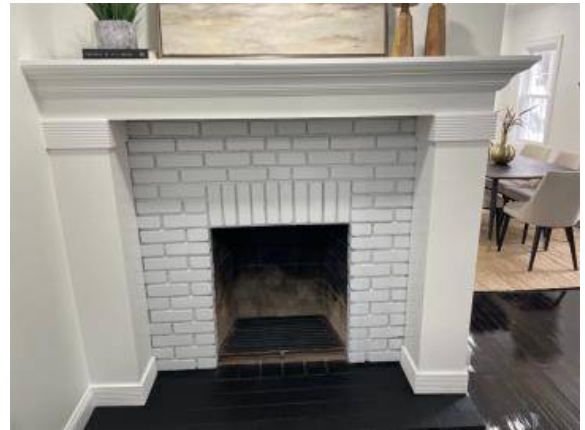
Location: Living Room

Fireplace Type: There is a masonry built wood burning fireplace installed.

Firebox: Acceptable- The firebox is sound and useable in its current condition.

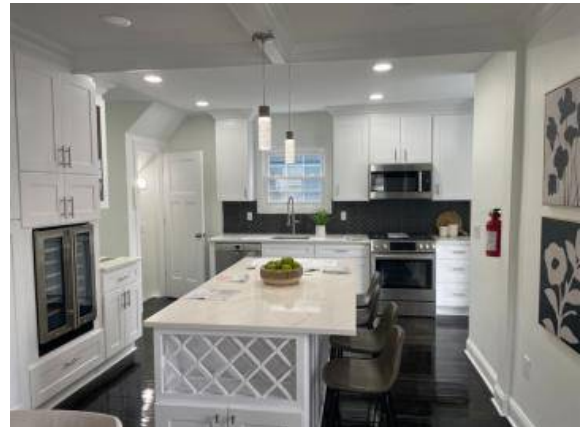
KITCHEN

Walls/Ceilings: Acceptable- The walls and ceiling are in acceptable condition.

Windows: Acceptable- The windows operated are in acceptable condition.

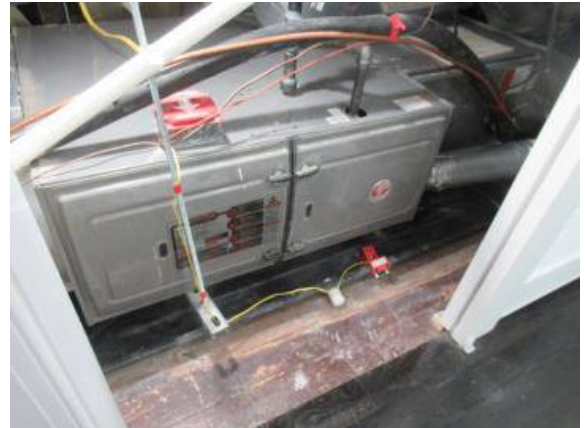
Gas Fired Warm Air Furnace

Heating System Location: Attic

Heating System Condition: Acceptable- The gas fired warm air furnace is in acceptable/functional condition. The system activates with a normal sequence of operation.

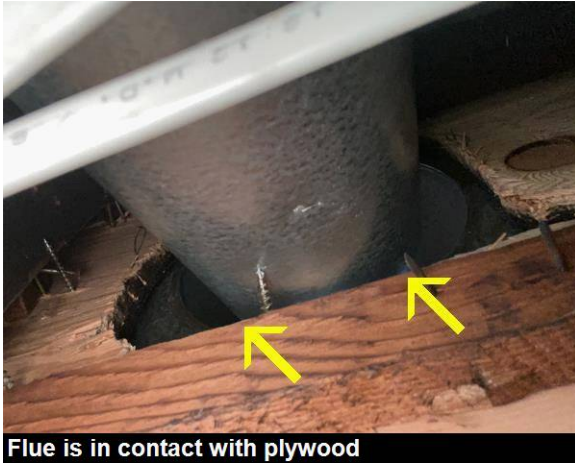
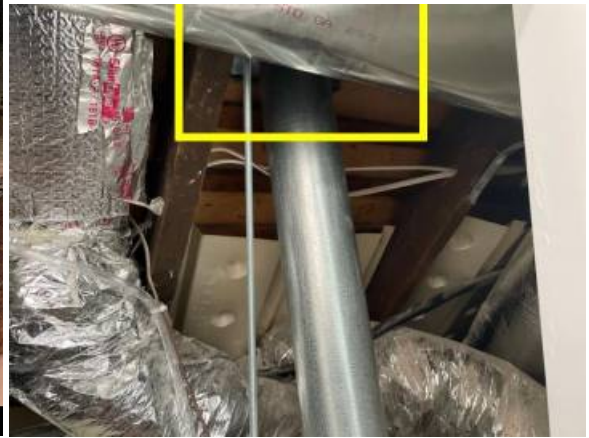
Exhaust/Flue Pipe: **Action Needed-** The metal exhaust vent/flue piping is a double wall type B vent, which requires at least a 1" clearance from combustibles. This installation does not meet the clearance safety requirements. Alteration of the vent and/or combustible material is necessary.

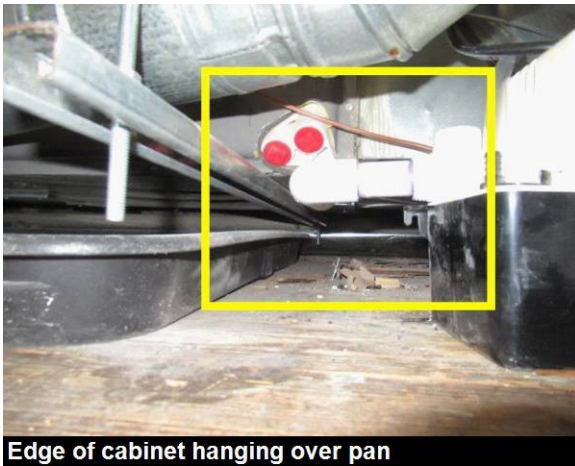
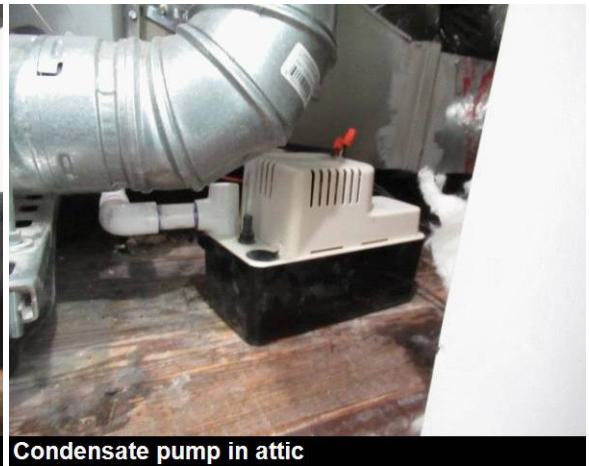
Action Needed- The condensate pan is not located properly under the air handler unit, which can allow water to leak into the ceiling below the unit. Relocate or replace the pan to catch water in the event of condensate spillage.

Attention Recommended- There is a pump installed to remove the condensate from the high efficiency heating system. The pump can't be tested during the inspection and should be checked periodically for proper function. An additional drain pan can be installed under the pump for added protection.

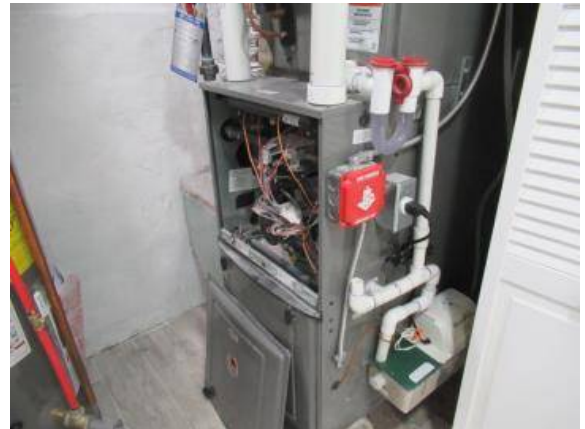
Gas Fired Warm Air Furnace #2

Heating System Location: Basement

Heating System Condition: Acceptable- The gas fired warm air furnace is in acceptable/functional condition. The system activates with a normal sequence of operation.

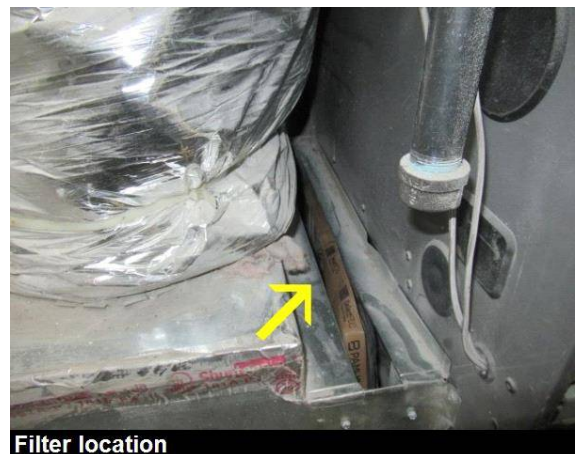
Filter location

The furnace filter should be replaced or cleaned every 30 days, or as needed for the particular type used.

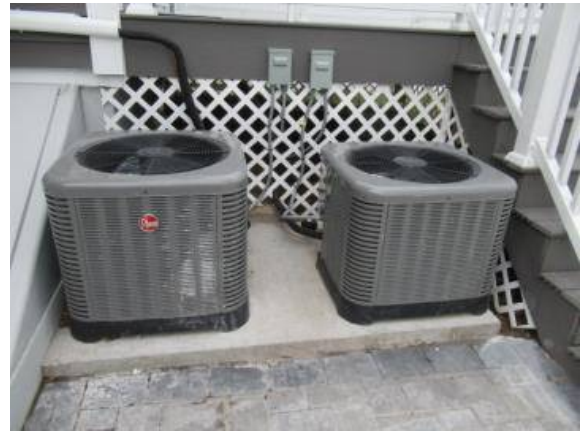
Two Separate Air Conditioning Systems

System Type: The electric central air conditioning is a split system type. The condenser units are at the exterior, and using the shared forced air heating system ductwork.

System Condition: The electric central air conditioning systems are **not tested** due to the low exterior temperature. Activating the exterior condenser unit could result in damage to the compressor. If conditions allow, the system should be operated prior to closing. Consult with your attorney regarding their procedure to ensure that the system will be in operational condition. It would be prudent to obtain a homeowner's warranty to cover any unforeseen circumstances.

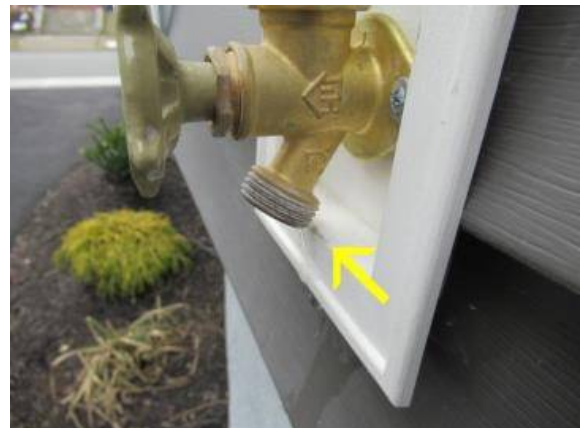
Exterior Hose Faucets: **Attention Recommended-** The spigot is tight against the vinyl trim. A hose may not fit onto the spigot. Alteration is needed for correct operation.

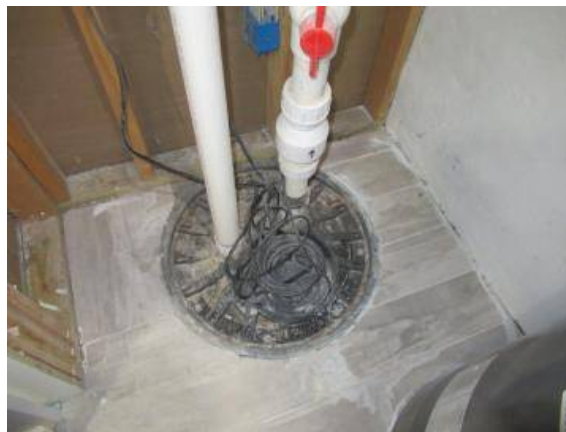
Sewage Ejector Pump:

Acceptable- The sewage ejector pump is functional. This pump serves the fixtures located in the basement.

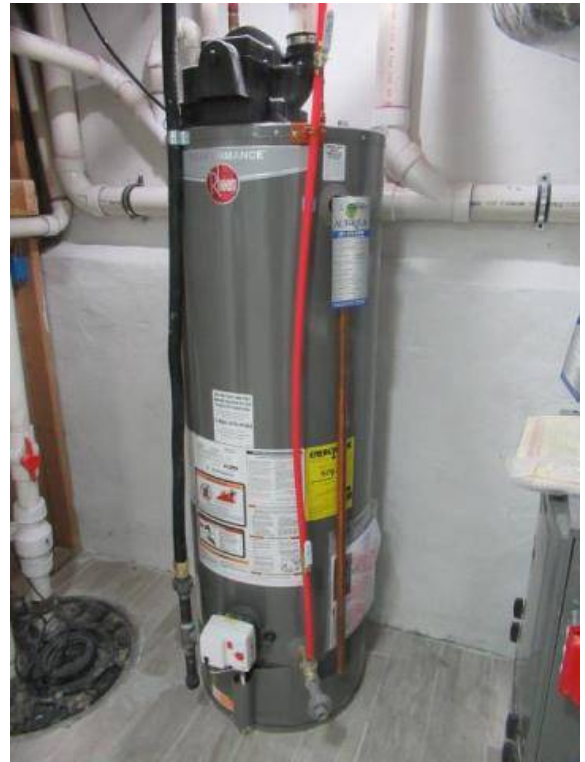
Water Heater

Acceptable- The gas fired water heater produces a functional flow and volume of hot water from fixtures throughout the house.

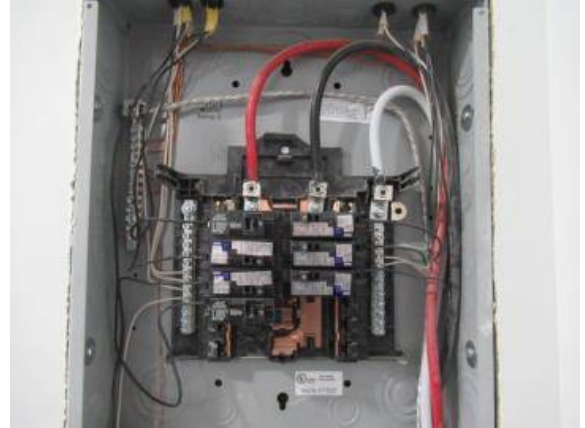
Sub Panel #1

Subpanel Wiring: Acceptable- The circuit breaker ratings in the subpanel appear to be appropriately matched to the circuit wire gauge.

Grounding: Acceptable- The visible ground cable(s) is in acceptable condition.
